**Flood Control Project Maintenance
Levee Inspections**

Fall 2014 Levee Maintenance Deficiency Summary Report

Reclamation District No. 0765 Glide

Waterway			Bank	Unit Miles
Unit No. 01 Sacramento River			Right	1.72
	Spring (March - May)	Summer (June - August)	(September - November) Fall	Winter (December - February)
Unit Maintenance Rating (Fall Only)			U	
Date of Inspection	03/03/2014 - 03/03/2014		10/27/2014 - 10/27/2014	
DWR Inspector	Richard Willoughby		Richard Willoughby	
Accompanied By	Everett Lovejoy RD 765		Everett Lovejoy RD 765

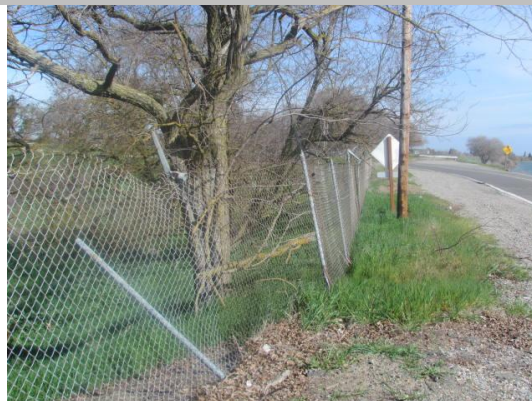
Photo 1 of 1 : FA_2014_RD0765_211_3_20141020_00003.jpg

Looking north (upstream) at trees on landside slope.

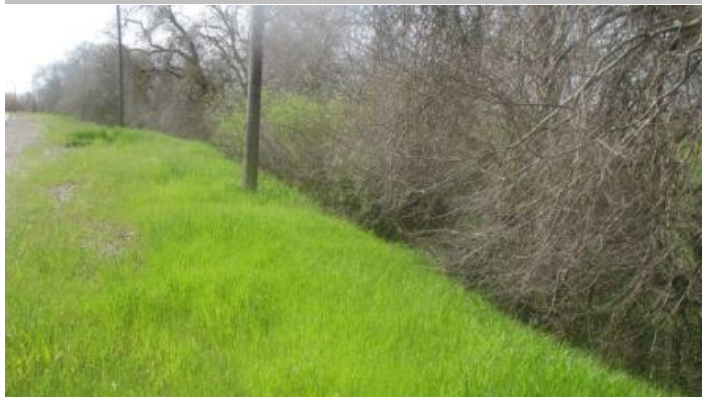
Photo 1 of 2 : FA_2014_RD0765_211_28_20141020_00036.jpg

Looking downstream (south) at trees on landside slope & toe.

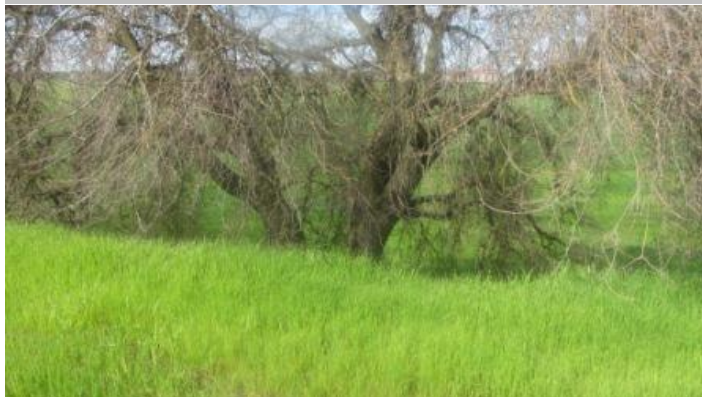
Photo 2 of 2 : FA_2014_RD0765_211_28_20141020_00037.jpg

Looking west at trees on landside toe.

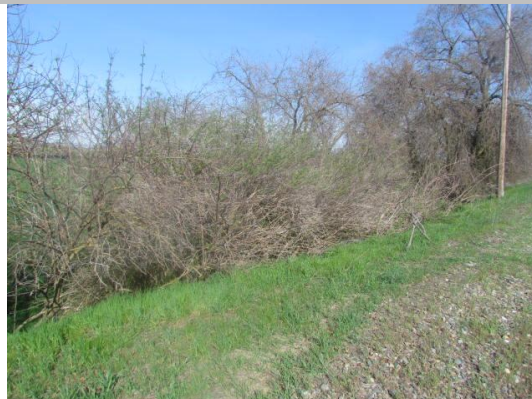
Photo 1 of 1 : FA_2014_RD0765_211_22_20141020_00033.jpg

Looking northwest at dense vegetation on landside slope.

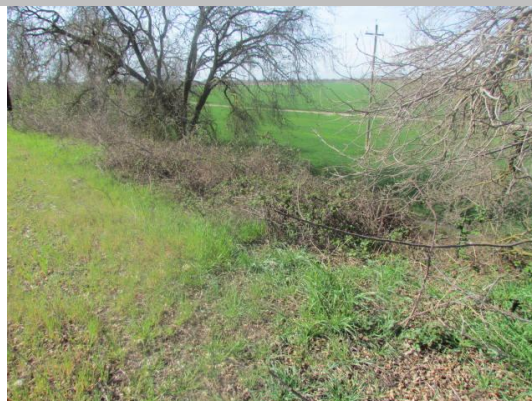
Photo 1 of 1 : FA_2014_RD0765_211_49_20141020_00057.jpg

Looking at wild berryvines or wild roses on landside slope and toe.

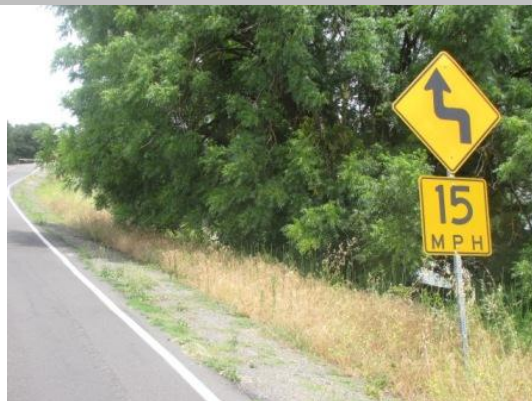
Photo 1 of 5 : FA_2014_RD0765_211_11_20141020_00015.jpg

LM Start	0.25	Rating **	A/W	Issue No.	11
LM End	0.28	Issue Type +	Ma	Location *	WS
Category	Earthen Levee			GPS Latitude/Longitude	
				Start	End
Item	Trim / Thin Trees			38.499405 °	38.499042 °
				-121.560445 °	-121.560430 °
DWR ID	DWR_RD0765_01_s_2012_11				
Action/Comments					
Thin trees to allow visibility of the ground and room to flood fight.

Looking northeast at overgrown trees on waterside slope.

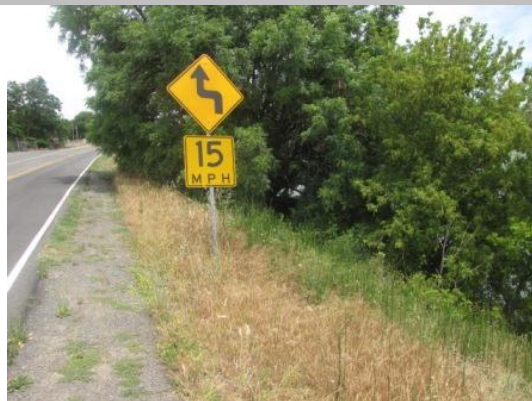
Photo 2 of 5 : FA_2014_RD0765_211_11_20141020_00016.jpg

Looking north at dense trees on waterside slope from fall 2010 inspection.

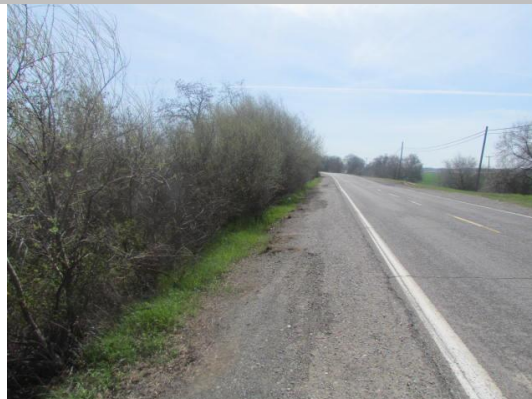
Photo 3 of 5 : FA_2014_RD0765_211_11_20141020_00017.jpg

Looking south (downstream) at dense trees on landside slope and shoulder. (Spring 2013)

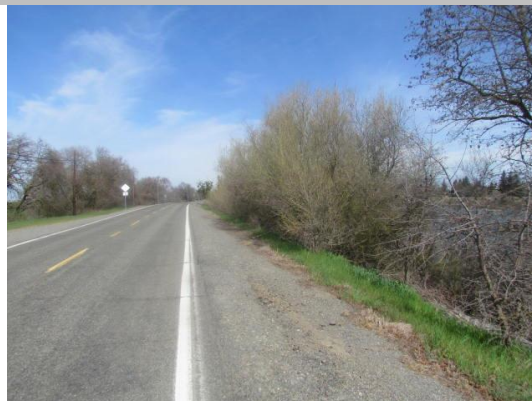
Photo 4 of 5 : FA_2014_RD0765_211_11_20141020_00018.jpg

Looking north (upstream) at dense trees on landside slope and shoulder. (Spring 2013)

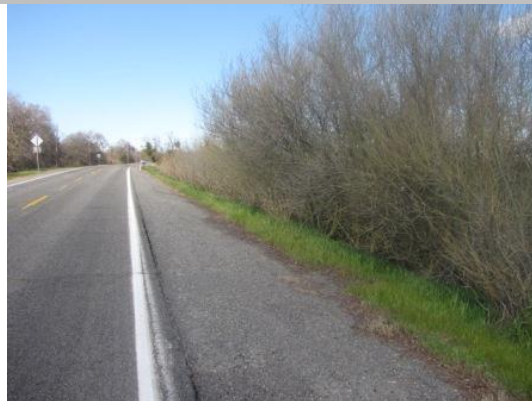
Photo 5 of 5 : FA_2014_RD0765_211_11_20141020_00019.jpg

Looking upstream (north) at dense vegetation and trees from 2011 spring inspection.

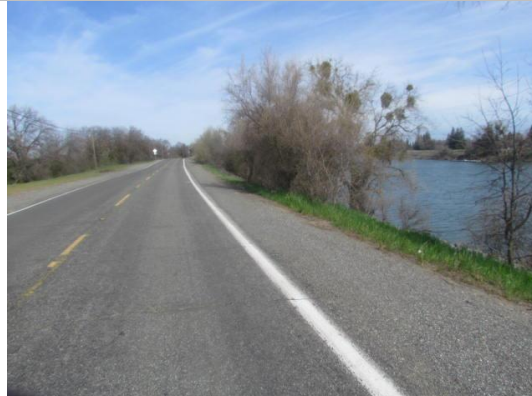
Photo 1 of 1 : FA_2014_RD0765_211_23_20141020_00034.jpg

Looking north (upstream) at untrimmed trees on waterside shoulder and slope.

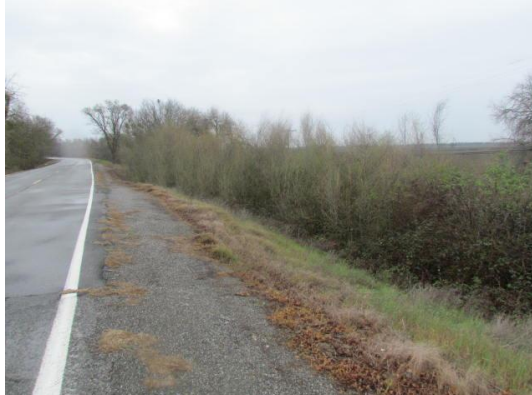
Photo 1 of 1 : FA_2014_RD0765_211_32_20141020_00043.jpg

Looking southwest at dense vegetation on landside slope and toe.

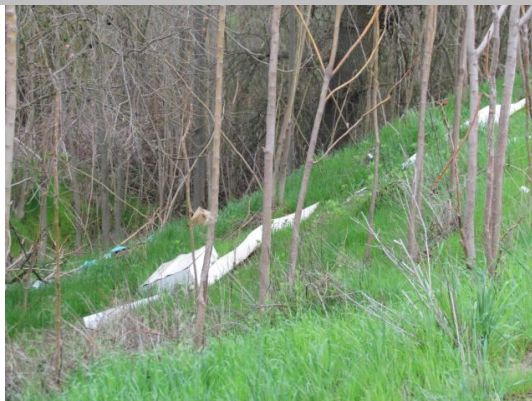
Photo 1 of 2 : FA_2014_RD0765_211_55_20141020_00063.jpg

LM Start	0.47	Rating **	A/W	Issue No.	55
LM End	0.47	Issue Type +	Ma	Location *	LS
Category	Earthen Levee			GPS Latitude/Longitude	
				Start	End
Item	Encroachments			38.496235 °	38.496235 °
				-121.559796 °	-121.559796 °
DWR ID	DWR_RD0765_01_f_2013_55				
Action/Comments					
Garbage					
Inspector Comments: Trash dumped on landside slope.

Looking northwest at garbage on landside slope.

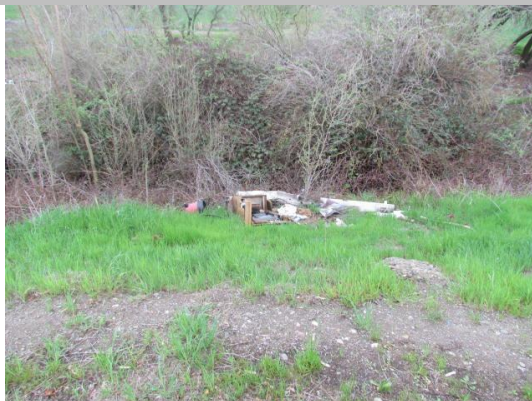
Photo 2 of 2 : FA_2014_RD0765_211_55_20141020_00064.jpg

Looking west at garbage on landside slope.

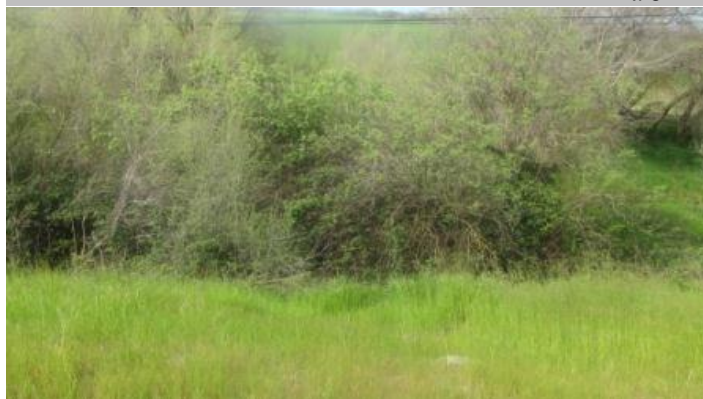
Photo 1 of 5 : FA_2014_RD0765_211_33_20141020_00044.jpg

Looking northwest at trees on landside toe from 2010 fall inspection.

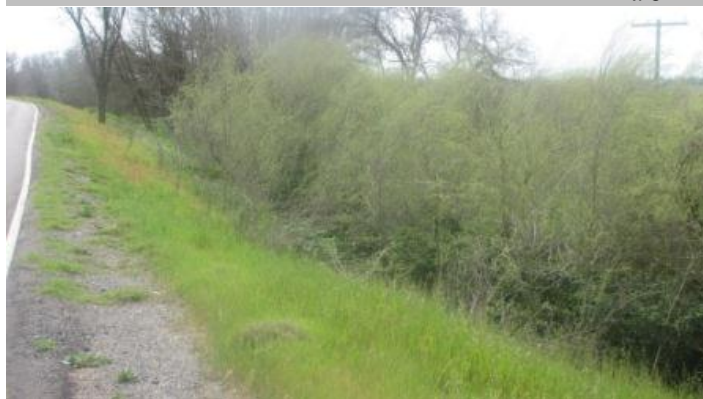
Photo 2 of 5 : FA_2014_RD0765_211_33_20141020_00045.jpg

Looking downstream (south) at trees on landside slope & toe.

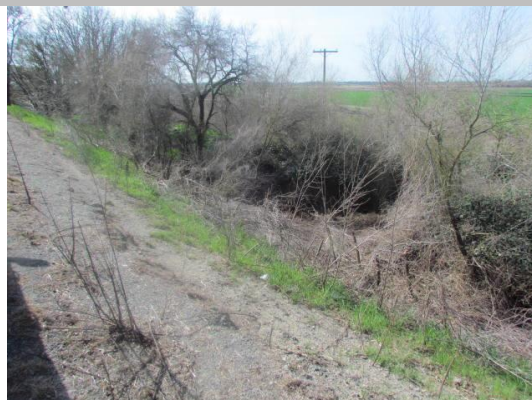
Photo 3 of 5 : FA_2014_RD0765_211_33_20141020_00046.jpg

Looking southwest at dense vegetation on landside slope and toe.

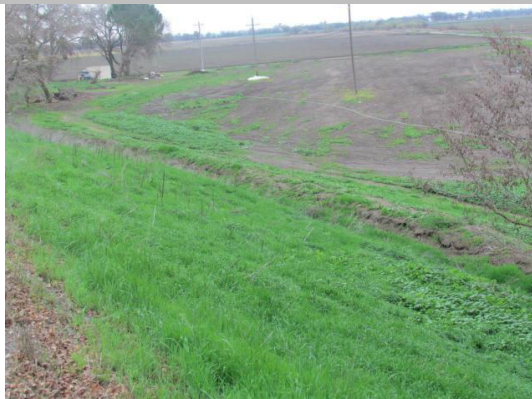
Photo 2 of 3 : FA_2014_RD0765_211_56_20141020_00065.jpg

Looking southwest at irrigation ditch running along landward toe.

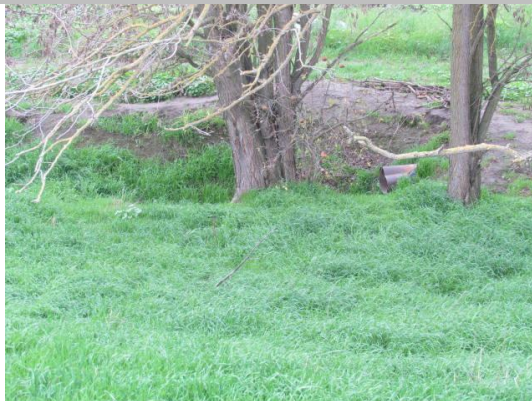
Photo 3 of 3 : FA_2014_RD0765_211_56_20141020_00066.jpg

Looking west at irrigation ditch at landward toe.

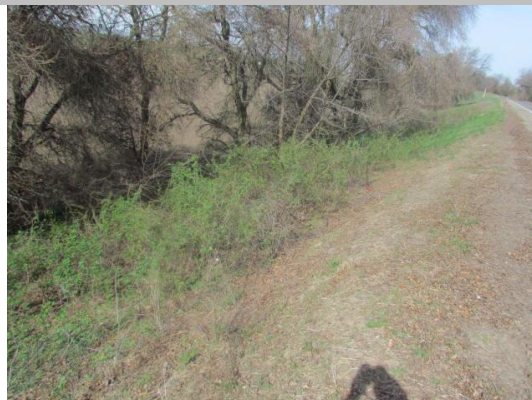
Photo 1 of 1 : FA_2014_RD0765_211_50_20141020_00058.jpg

Looking northwest at vegetation on landside slope.

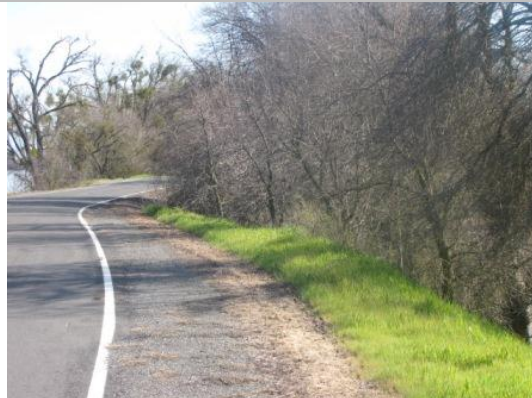
Photo 1 of 6 : FA_2014_RD0765_211_17_20141020_00024.jpg

Looking downstream (south) at dense trees on landside slope and toe.

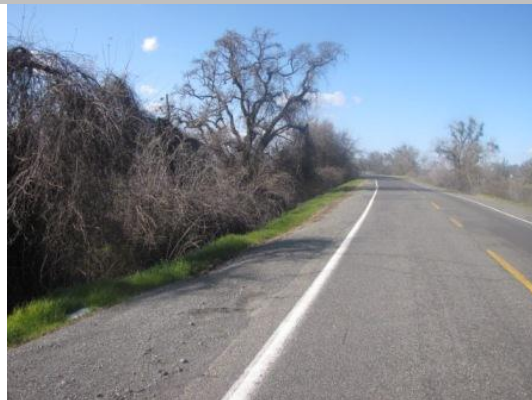
Photo 2 of 6 : FA_2014_RD0765_211_17_20141020_00025.jpg

Looking upstream (north) at dense trees on landside slope and toe.

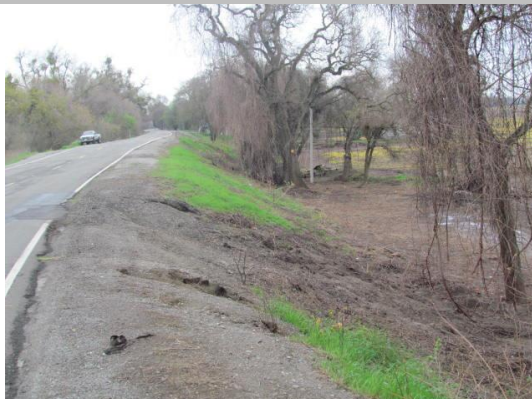
Photo 3 of 6 : FA_2014_RD0765_211_17_20141020_00026.jpg

Looking south at trimmed trees and vegetation on landside slope and toe.

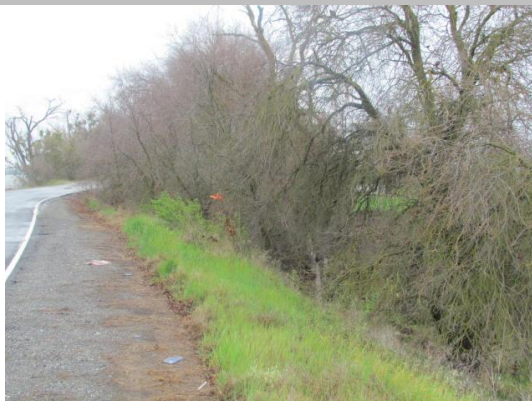
Photo 4 of 6 : FA_2014_RD0765_211_17_20141020_00027.jpg

Looking southwest at dense trees on landside slope and toe spring 2012.

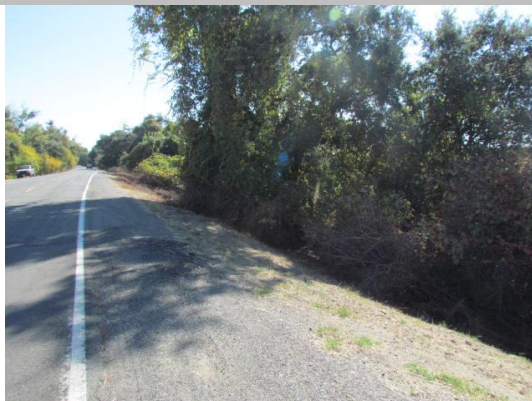
Photo 5 of 6 : FA_2014_RD0765_211_17_20141020_00028.jpg

Looking southwest at dense vegetation on landward slope.

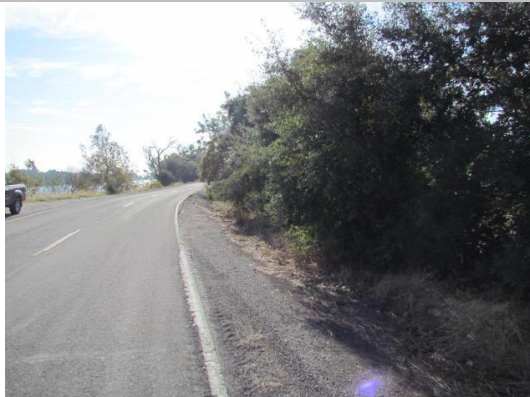
Photo 6 of 6 : FA_2014_RD0765_211_17_20141020_00029.jpg

Looking south at dense trees on landside shoulder and slope.
(November 2011)

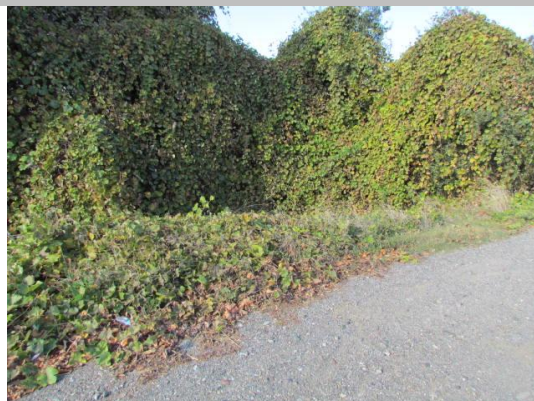
Photo 1 of 5 : FA_2014_RD0765_211_81_20141020_00069.jpg

Looking west at dense berryvines and wildroses on landside shoulder and slope. (November 2011)

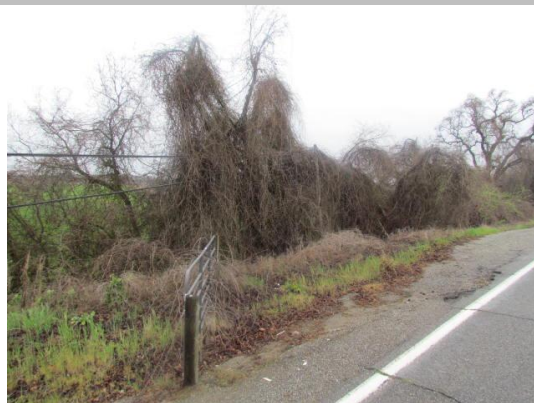
Photo 2 of 5 : FA_2014_RD0765_211_81_20141020_00070.jpg

Looking northwest at vines on landside toe spring 2012.

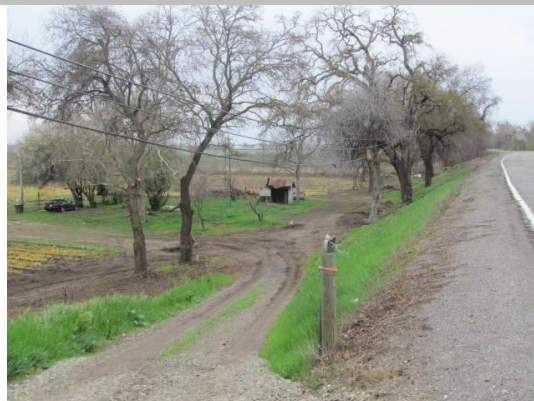
Photo 3 of 5 : FA_2014_RD0765_211_81_20141020_00071.jpg

Looking northwest at trimmed trees and vegetation on landside slope and toe.

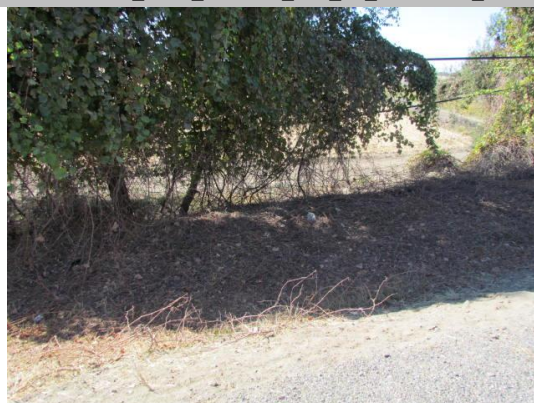
Looking west at trimmed trees on landward slope.

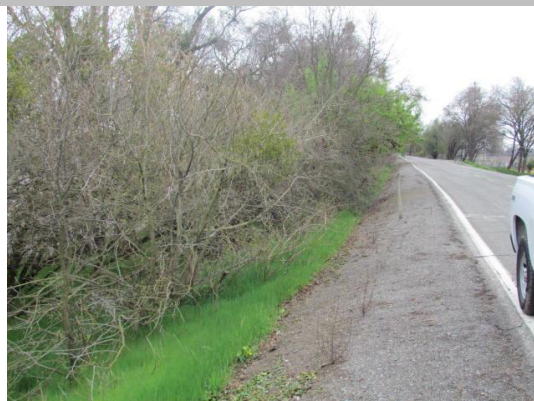
Photo 1 of 2 : FA_2014_RD0765_211_6_20141020_00007.jpg

Looking south (downstream) at untrimmed trees on waterward slope.

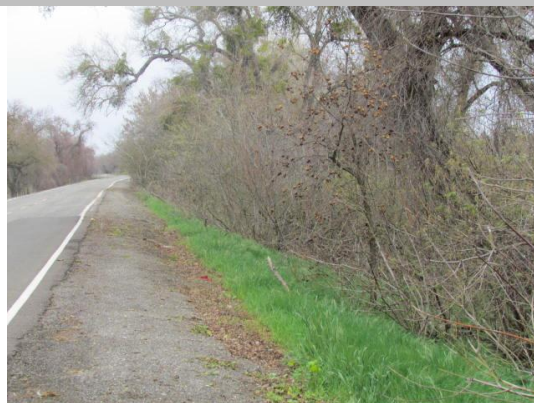
Photo 2 of 2 : FA_2014_RD0765_211_6_20141020_00008.jpg

Looking north (upstream) at untrimmed trees on waterward slope.

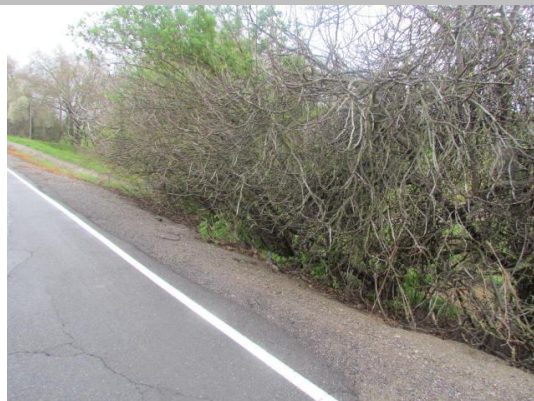
Photo 1 of 1 : FA_2014_RD0765_211_40_20141020_00053.jpg

Looking southwest at fig trees and other trees on landside slope and toe.

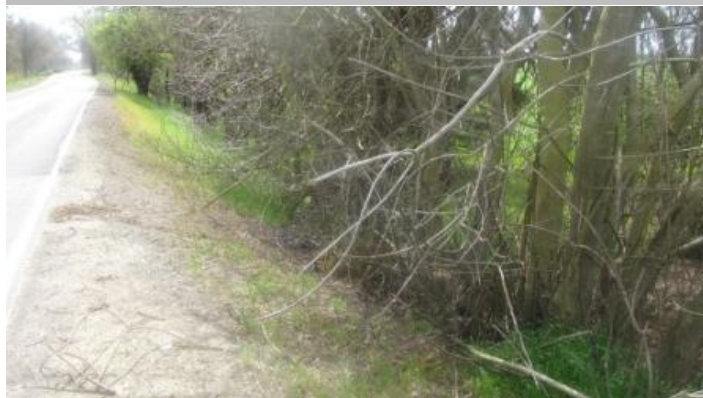
Photo 1 of 4 : FA_2014_RD0765_211_37_20141020_00049.jpg

Looking downstream (south) at trees on landside slope & toe from 2010 fall inspection.

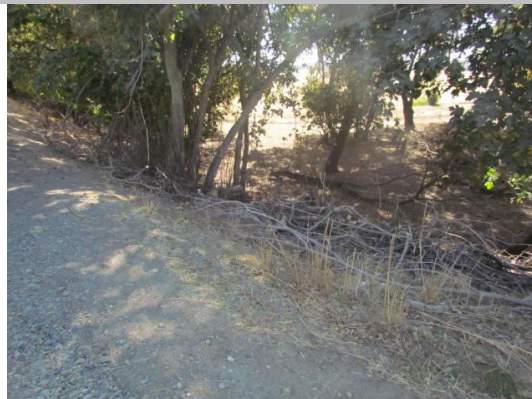
Photo 2 of 4 : FA_2014_RD0765_211_37_20141020_00050.jpg

Looking southwest at trees on landward slope.

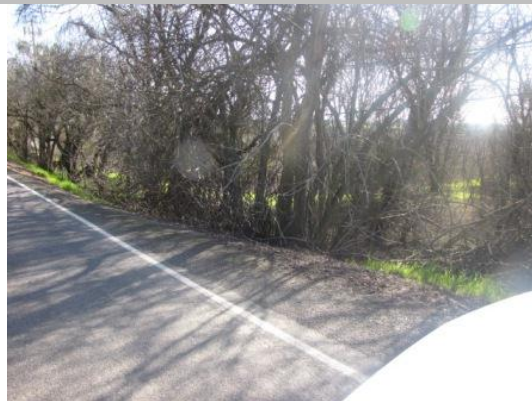
Photo 3 of 4 : FA_2014_RD0765_211_37_20141020_00051.jpg

Looking downstream (southwest) at dense trees on landside slope and toe.

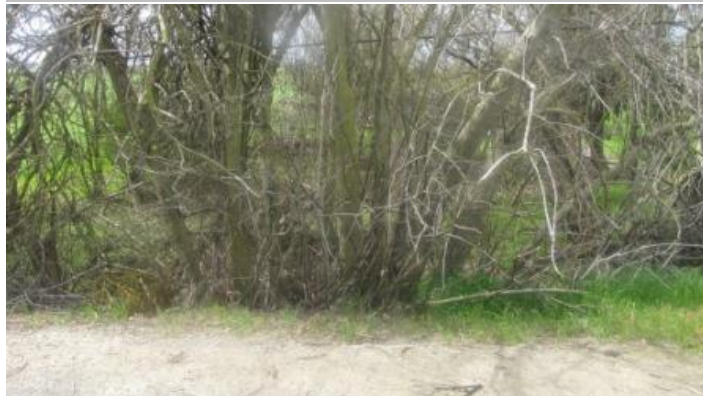
Photo 4 of 4 : FA_2014_RD0765_211_37_20141020_00052.jpg

Looking west at trees on landside slope & toe.

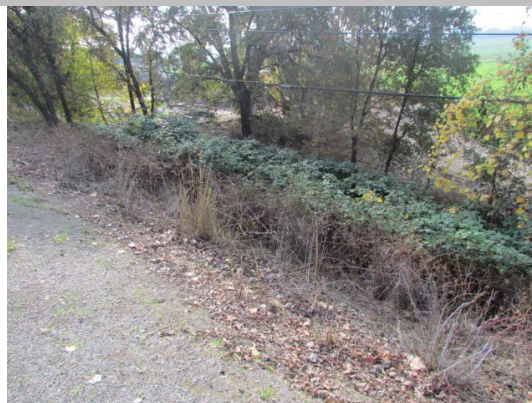
Photo 1 of 1 : FA_2014_RD0765_211_48_20141020_00056.jpg

Looking southwest at dense vegetation on landside slope and toe.

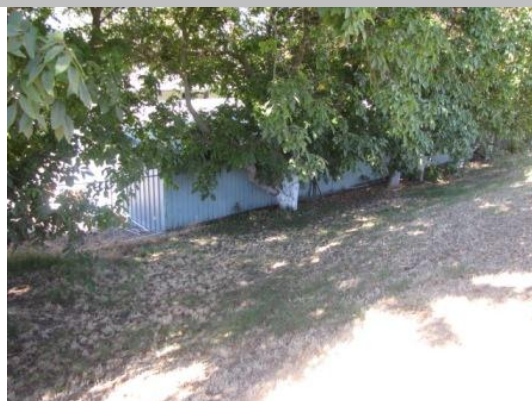
Photo 1 of 1 : FA_2014_RD0765_211_43_20141020_00054.jpg

Looking northwest at buildings along landside toe.

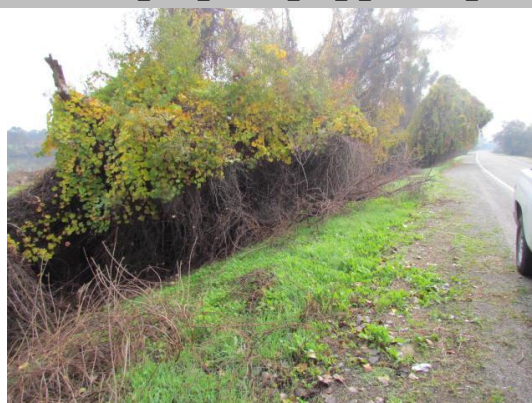
Photo 1 of 2 : FA_2014_RD0765_211_7_20141020_00009.jpg

Looking southeast at dense vegetation on waterside slope. (Fall Inspection 2012)

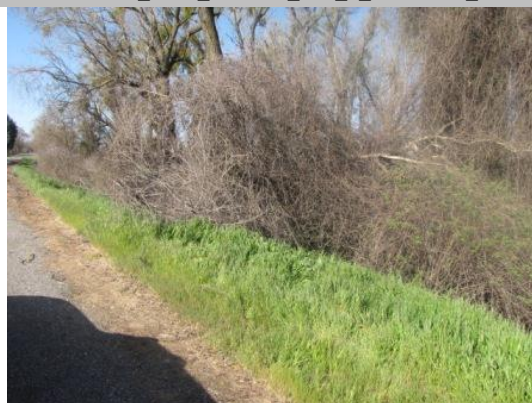
Photo 2 of 2 : FA_2014_RD0765_211_7_20141020_00010.jpg

Looking upstream (north) at dense vegetation on waterside slope.

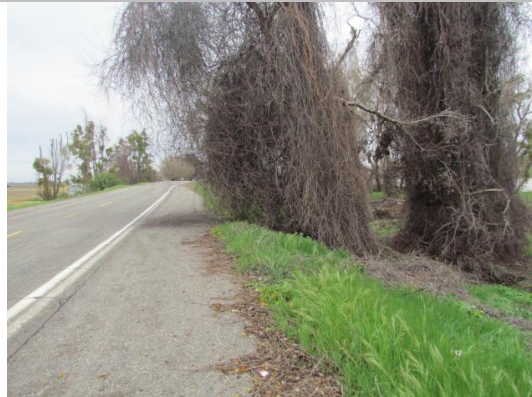
Photo 1 of 1 : FA_2014_RD0765_211_4_20141020_00004.jpg

Looking north at untrimmed trees on waterward slope.

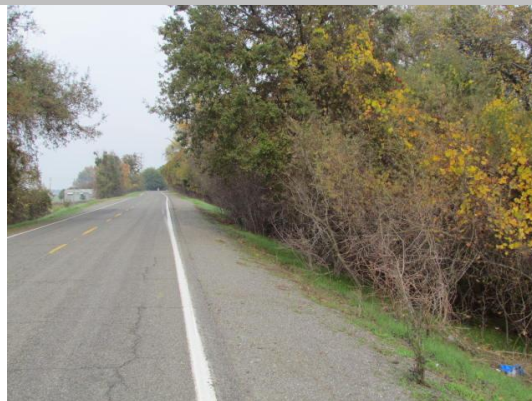
Photo 1 of 2 : FA_2014_RD0765_211_5_20141020_00005.jpg

Looking north at dense vegetation on waterside slope. (Fall Inspection 2012)

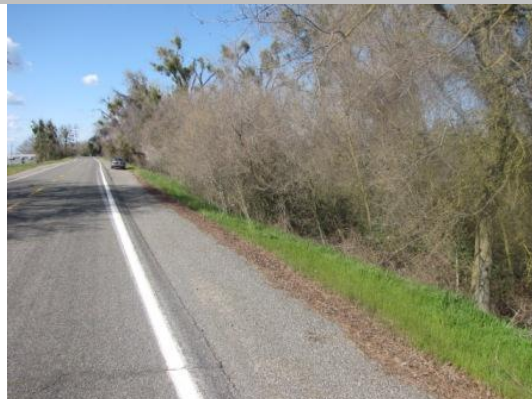
Photo 2 of 2 : FA_2014_RD0765_211_5_20141020_00006.jpg

Looking upstream (north) at dense trees on waterside slope.

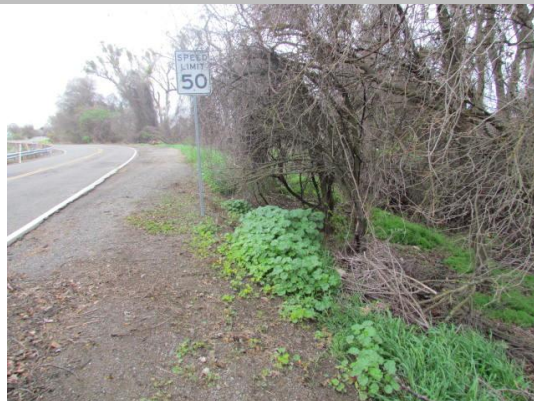
Photo 1 of 2 : FA_2014_RD0765_211_1_20141020_00001.jpg

Looking north at vegetation on waterward slope.

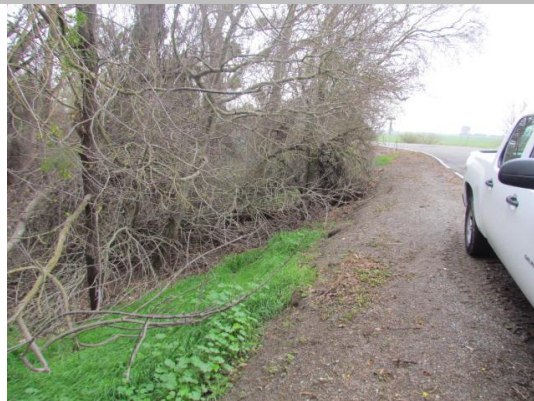
Photo 2 of 2 : FA_2014_RD0765_211_1_20141020_00002.jpg

Looking southeast at vegetation on waterward slope.

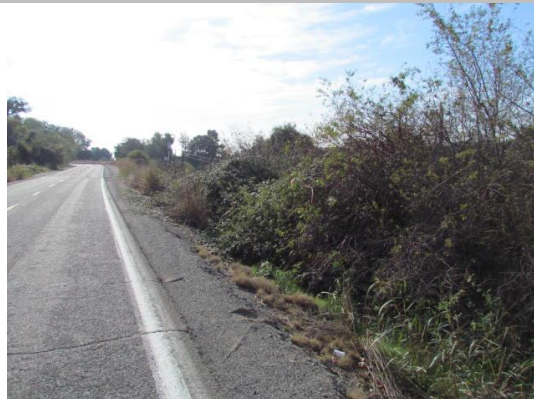
Photo 1 of 6 : FA_2014_RD0765_211_29_20141020_00038.jpg

Looking south at dense vegetation on landside shoulder and slope.
(November 2011)

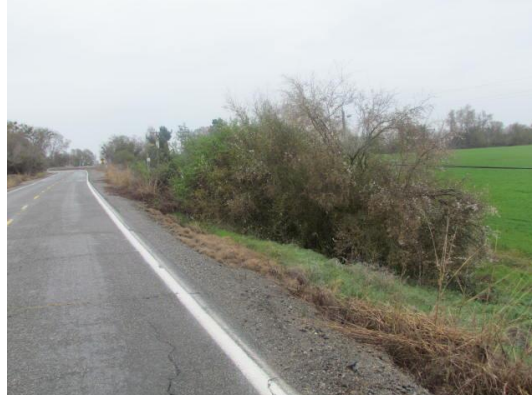
Photo 2 of 6 : FA_2014_RD0765_211_29_20141020_00039.jpg

Looking south at dense vegetation on landside slope and toe spring 2012.

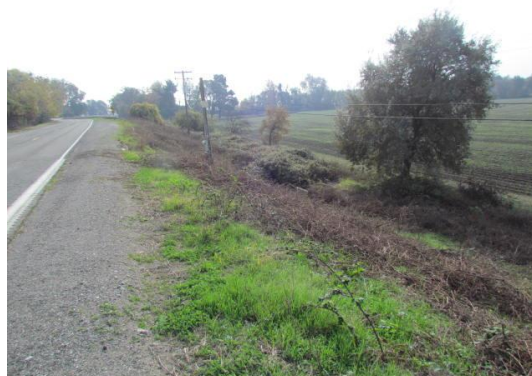
Photo 3 of 6 : FA_2014_RD0765_211_29_20141020_00042.jpg

Looking southwest at vegetation on landside slope and toe. (Fall Inspection 2012)

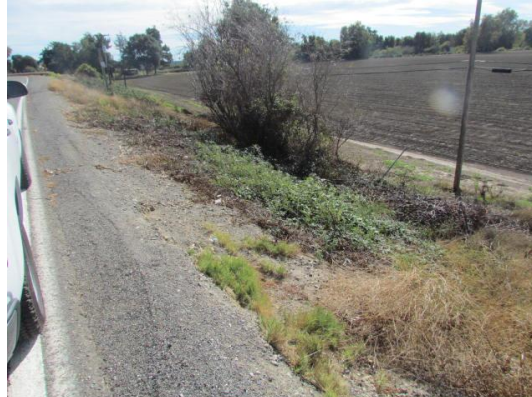
Photo 4 of 6 : FA_2014_RD0765_211_29_20141030_00075.jpg

Looking south at moderate vegetation on landward slope and toe. (Fall 2014)

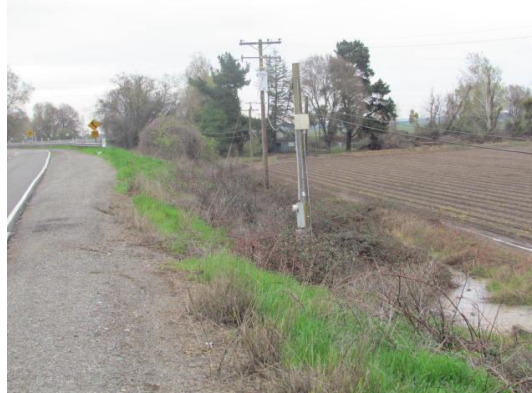
Photo 5 of 6 : FA_2014_RD0765_211_29_20141020_00040.jpg

Looking southwest at berryvines on landside slope.

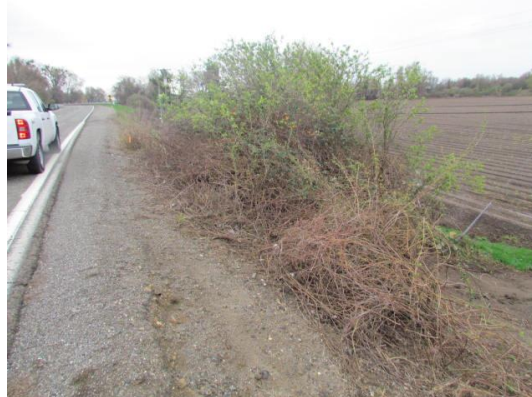
Photo 6 of 6 : FA_2014_RD0765_211_29_20141020_00041.jpg

Looking southwest at vegetation on landside slope.

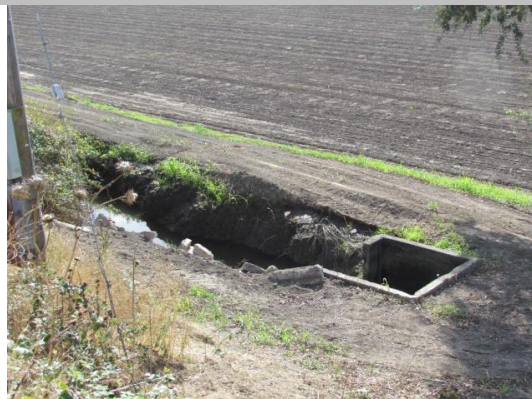
Photo 1 of 2 : FA_2014_RD0765_211_60_20141030_00076.jpg

Looking southwest at irrigation ditch at landward toe.(Fall 2014)

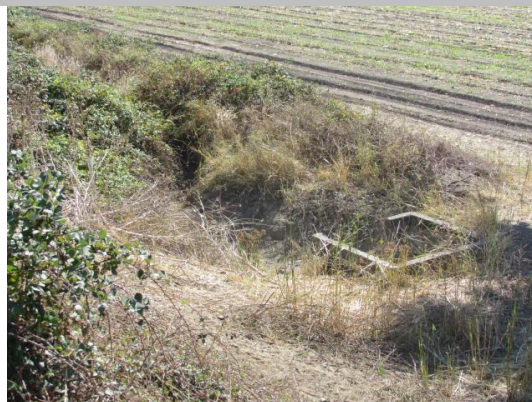
Photo 2 of 2 : FA_2014_RD0765_211_60_20141020_00068.jpg

Looking southwest at irrigation ditch on landward toe.

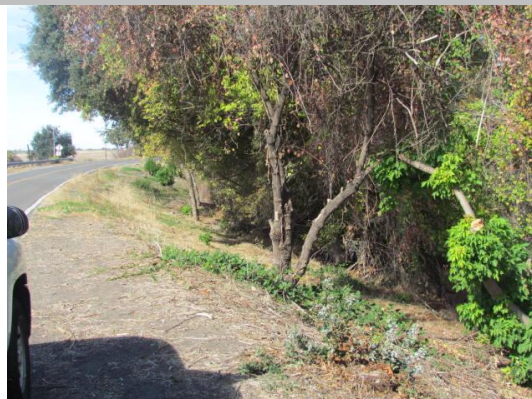
Photo 1 of 2 : FA_2014_RD0765_211_53_20141030_00077.jpg

Looking north at trimmed trees on waterward slope. (Fall 2014)

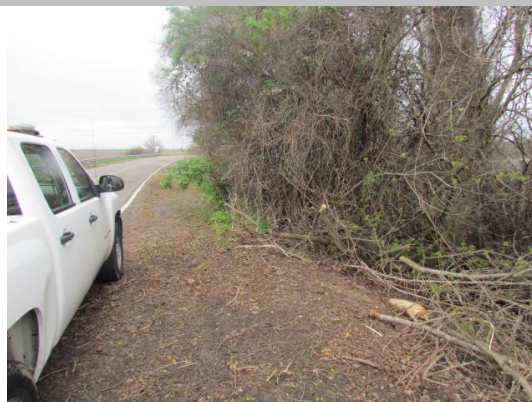
Photo 2 of 2 : FA_2014_RD0765_211_53_20141020_00061.jpg

Looking north at dense vegetation on waterward slope.

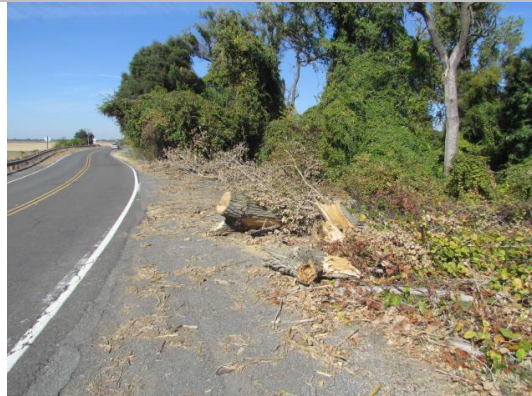
Photo 1 of 3 : FA_2014_RD0765_211_13_20141020_00020.jpg

Looking northeast at tree limbs on waterward slope.

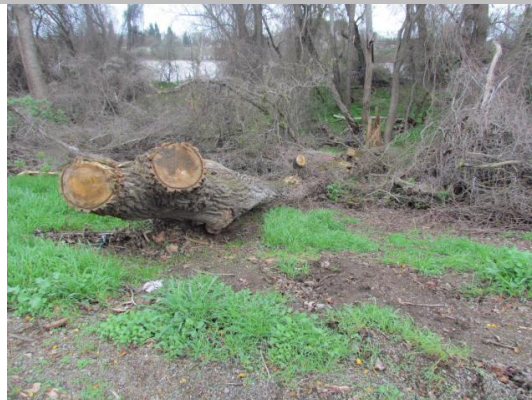
Photo 2 of 3 : FA_2014_RD0765_211_13_20141020_00021.jpg

Looking east at large tree limb on waterward slope.

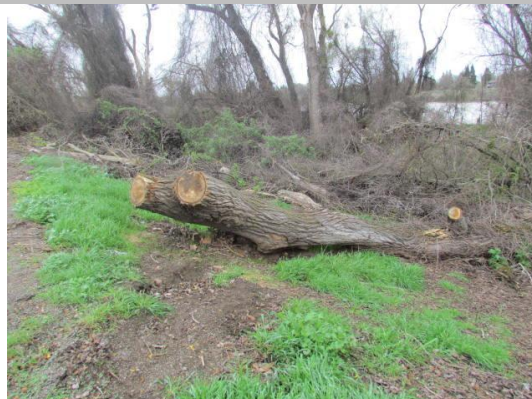
Photo 3 of 3 : FA_2014_RD0765_211_13_20141020_00022.jpg

Looking north at large tree limb on waterward slope.

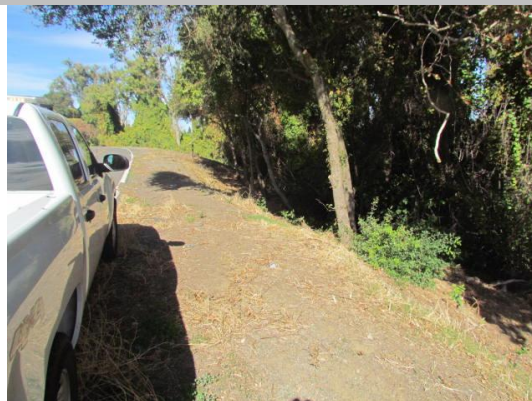
Photo 1 of 2 : FA_2014_RD0765_211_52_20141030_00078.jpg

Looking north (upstream) at trimmed trees on landward slope. (Fall 2014)

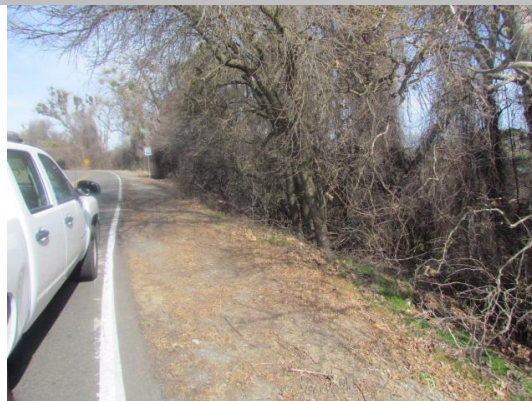
Photo 2 of 2 : FA_2014_RD0765_211_52_20141020_00060.jpg

Looking north (upstream) at dense trees on landside slope.
